Building Number: 38

Original Name: Dormitory

Building 38, Truro Air Base, North Truro, Massachusetts

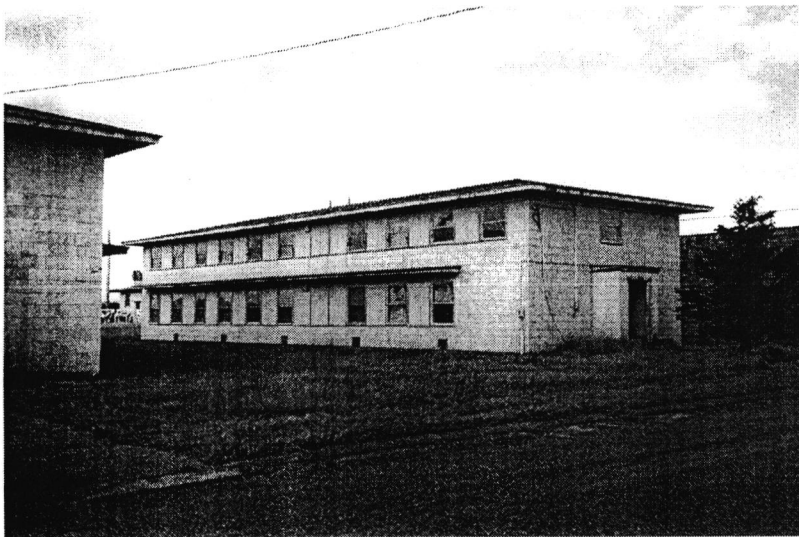
View from southwest.

Very low pitch hipped roof with composite shingles in **poor condition**; leaks on east side. Deep overhangs in **fair/poor condition**. Wood soffit between floors is rotted and paint is peeling.

2-story, wood frame structure sheathed in cement asbestos shingles is in **poor condition**. Metal grates at first floor level rusted/ missing. 47 aluminum double hung windows; all seals have failed. 3 wood flush doors in **poor condition**; paint is cracked and peeling and hinges are rusted. 2 flat-roofed vestibules with mildew damage and peeling paint. Steel fire escape is rusted and falling apart.

All wood window and door trim and wood fascia in **poor condition**. Wood is rotted and paint is cracked or peeling. Metal drip edge at foundation is rusted.

CMU foundation walls and piers in fair condition. Vestibules sit on concrete pads with 2 steps up. **Condition is fair/poor**. Mildew damage.
